UNITED STATES
DEPARTMENT OF THE INTERIOR
BUREAU OF MINES

From: J. T. Whalen, Federal Coal-Mine Inspector, and J. L. Gilley,
Mining Health and Safety Engineer

Subject: Report on Investigation of Minor Coal-Mine Bump, No. 9 mine,
Jewell Eagle Coal Company, Melville, Logan County, West Virginia,
August 18, 1959

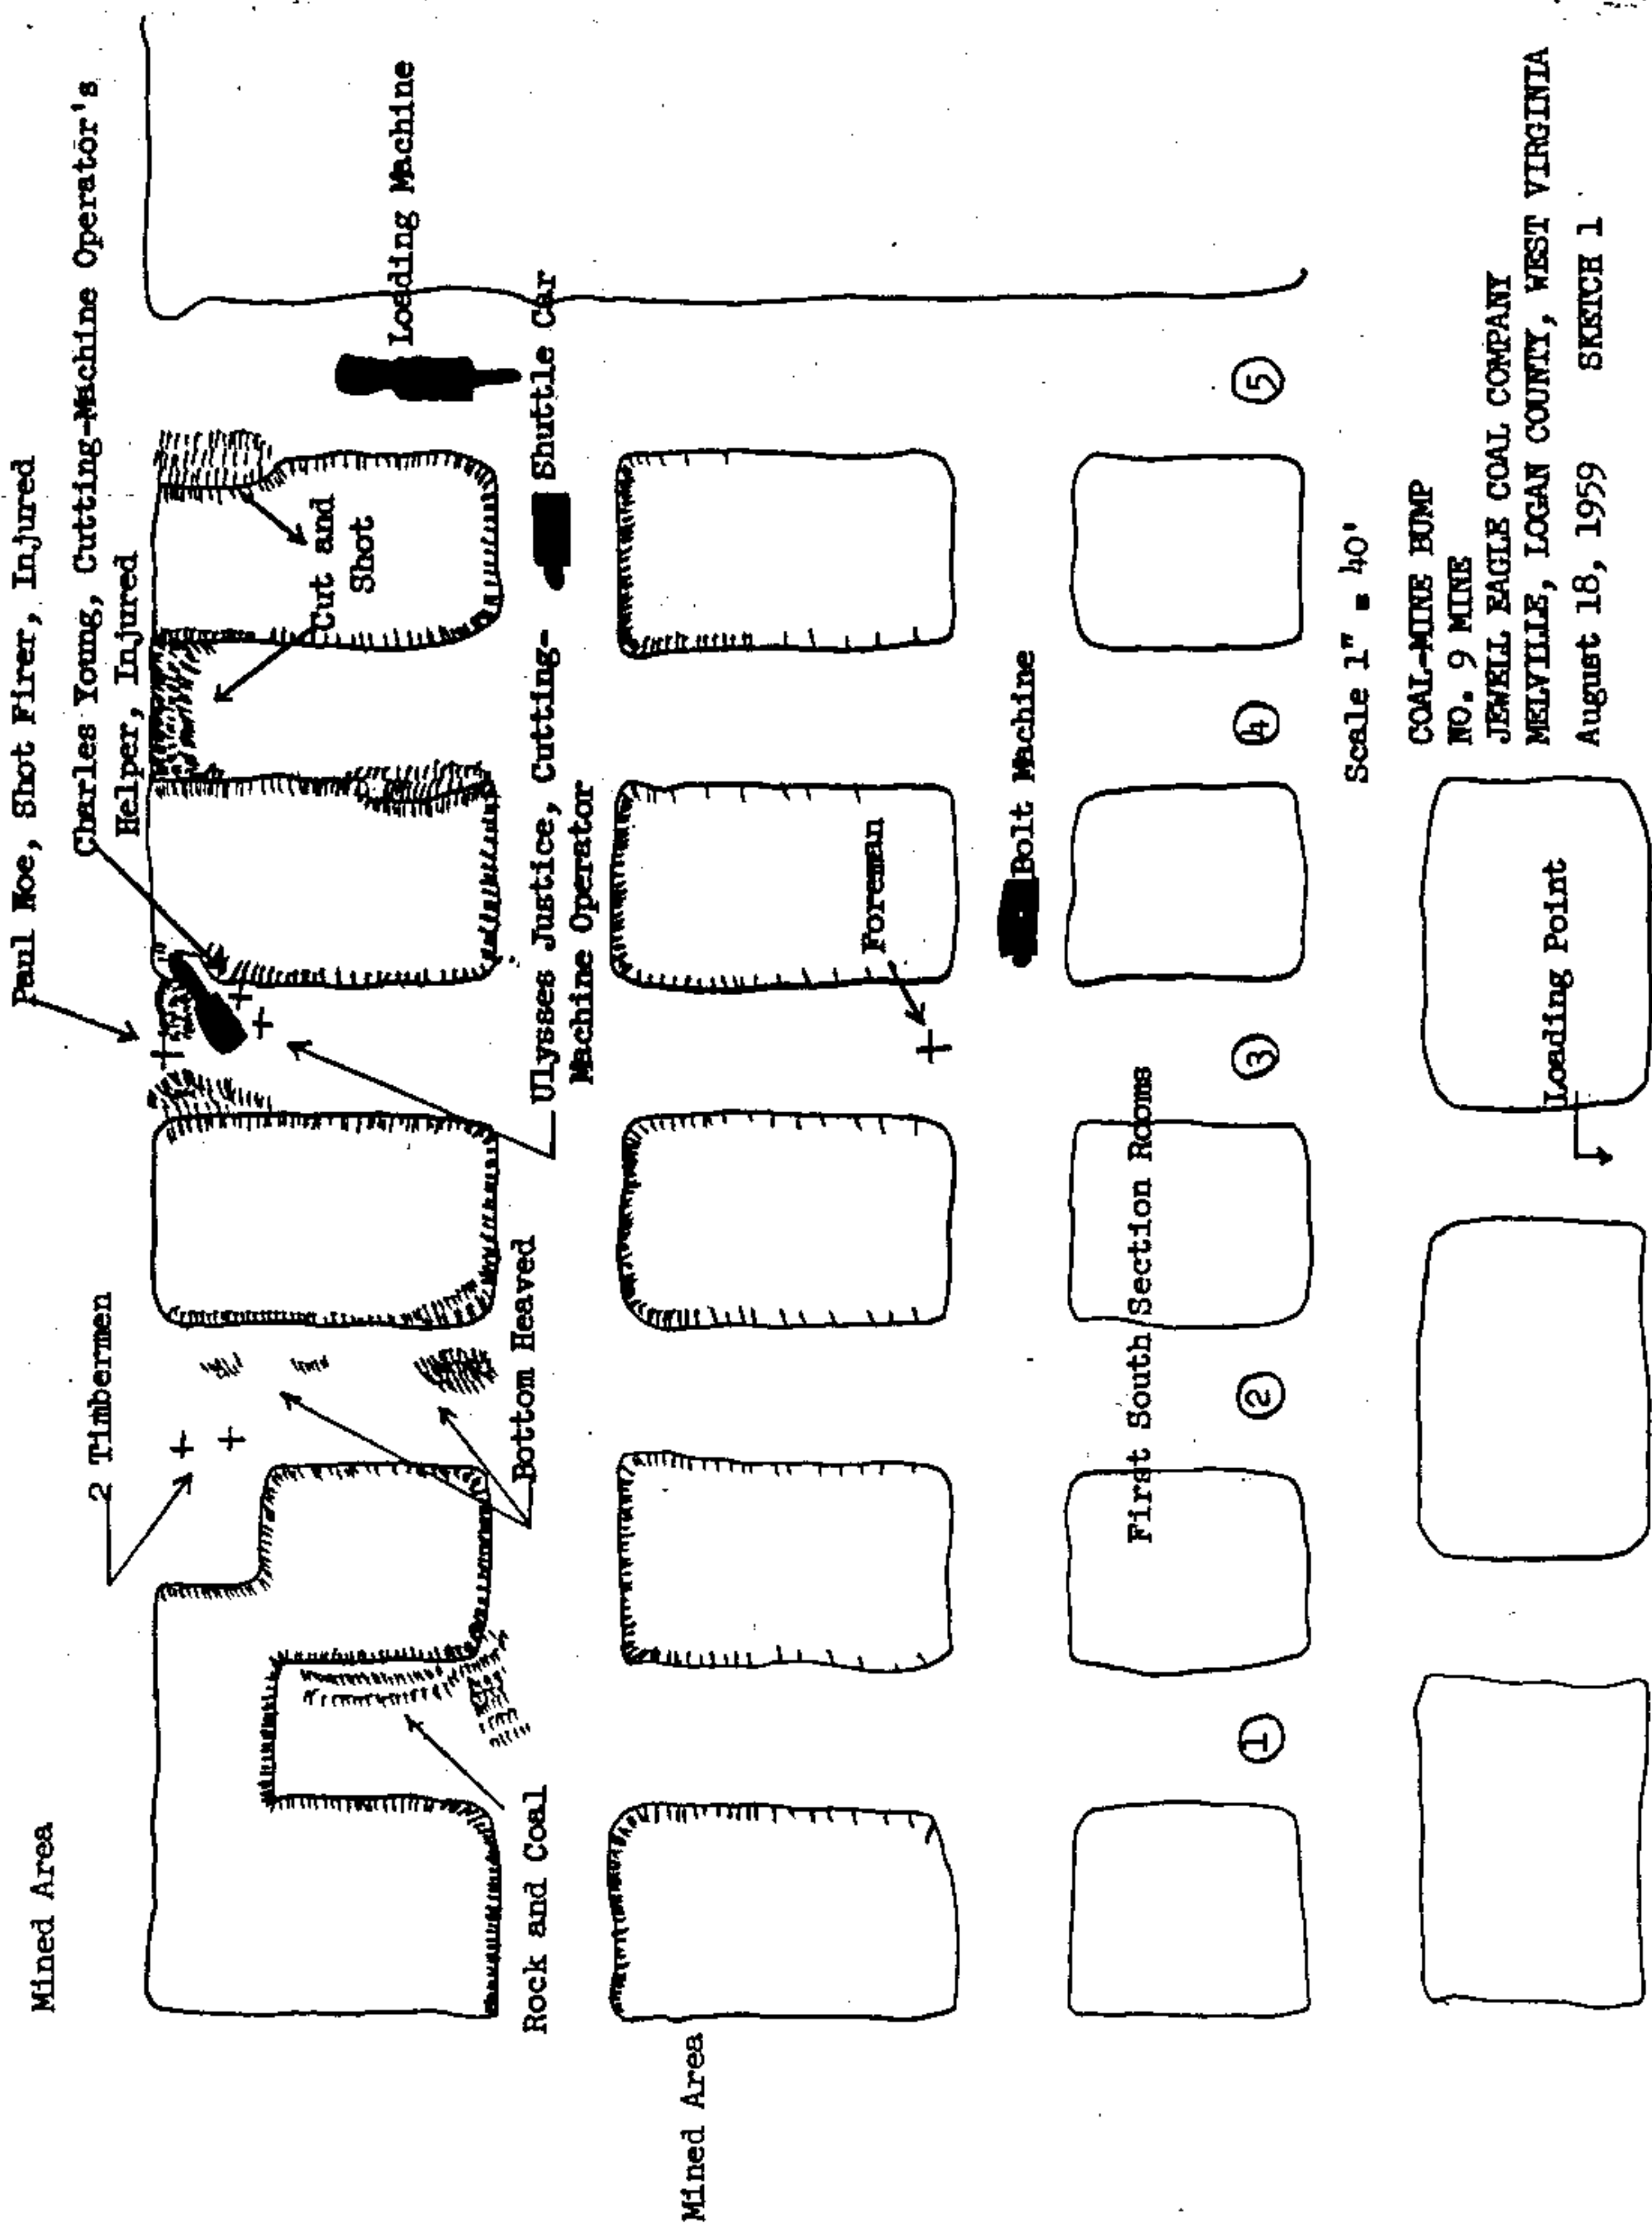
COAL-MINE BUMP
 NO. 9 MINE
 JEWELL EAGLE COAL COMPANY
 MELVILLE, LOGAN COUNTY, WEST VIRGINIA
 August 18, 1959 SKETCH 1

Location of the faces of the 5 rooms and the location of the men and equipment at the time of the bump are indicated in Sketch 1. It will

be noted that the No. 1 room lacked 22 feet being completed, the No. 2 room had holed through, and an open-end lift had been advanced to a depth of 20 feet into the pillar between Nos. 1 and 2 rooms. The No. 3 room had holed through into the gob and the last cut of coal at the face of No. 4 room had been cut and blasted. The No. 5 room had holed through and the first cut in the pillar lift to the left had been cut and blasted. Three of the rooms, Nos. 3, 4, and 5, had cut or holed through during the evening shift. The only men performing work at or near the working faces at the time of the bump were 2 timber men setting timbers near the entrance to the pillar lift in No. 2 room and the cutting-machine crew and shot firer in No. 3 room.

From Sketch 1 it will be further noted that pillar recovery had started in Nos. 2, 3, and 5 rooms although the No. 1 room which was in the most critical area lacked 22 feet or more being completed at the time the bump occurred, consequently, the extraction of some of the pillars was started out of proper sequence. From Sketch 2 it will be noted that coal pillars and remnants of pillars of various dimensions were left unmined in by the active working area, and, reportedly, coal pillars of varying dimensions were left unmined in the 2 butt left gob area. These unmined pillars and pillar remnants probably delayed and/or prevented the massive roof from caving as it should, thus likely imposing additional stress on the newly developed room pillars in the area involved.

it was learned during this investigation that a bump occurred while the loading machine was operating at the face of the No. 1 room with sufficient force to throw 3 or 4 tons of coal from the adjacent ribs. After this bump, the loading-machine operator trammed the machine back to the last inby open crosscut in No. 1 room and waited until the section foreman examined the place. The foreman stated that he did not discover anything unusual and instructed the loading-machine operator to load the loose coal thrown out into the roadway and finish loading the coal in the face. After the place was cleaned up, the loading machine was trammed into No. 5 room and had reached the location indicated in Sketch 1 when the bump occurred that injured the 2 workmen working in No. 3 room.

From all indications, this coal-mine bump was the result of the imposition of a shock load onto the pillars indicated in Sketch 1, particularly the inby pillars of Nos. 1, 2, 3, and 4 rooms flanked by the old gob of 2 butt left. The bump could have been triggered by stresses from percussion created by the cutting machine penetrating the coal of a comparatively highly stressed pillar. According to information from local officials, bumps of such intensity have not occurred previously at this mine; however, several outbursts, some resulting in fatalities, have occurred in a mine operating in the same coal bed on an adjoining property.

1. A system of mining should be adopted that will produce the least number of critical areas during retreat mining. Critical areas are produced by pillar line points, pillars not developed sufficiently in advance, improper sequence in development and extraction.

2. Under no circumstances, where the natural conditions are conducive to or favorable for outbursts, should groups of rooms (such as those involved) be driven or developed abreast into stressed areas of coal pillars (abutment pressure zone) toward the gob.

3. The mining system should require that coal pillars be developed as nearly uniform in shape and size as practicable.
4. Complete extraction should be striven for and pillar remnants should not be left. If it is not possible to recover such pillar remnants, their load-carrying capacity should be destroyed.

5. Pillars should be recovered in a straight line. Irregular pillar lines result in excessive pressures on the pillar line points. (Those jutting into the gobs.) Experience has shown, however, that the lead end (top end) of a pillar line can be kept slightly in advance.

6. Widths of roadways in rooms and entries, including crosscut openings, should be kept to the minimum required by the approved mining plan (entries - 20 feet, rooms - 20 to 24 feet). The adopted mining plans and practices should be complied with at all times.

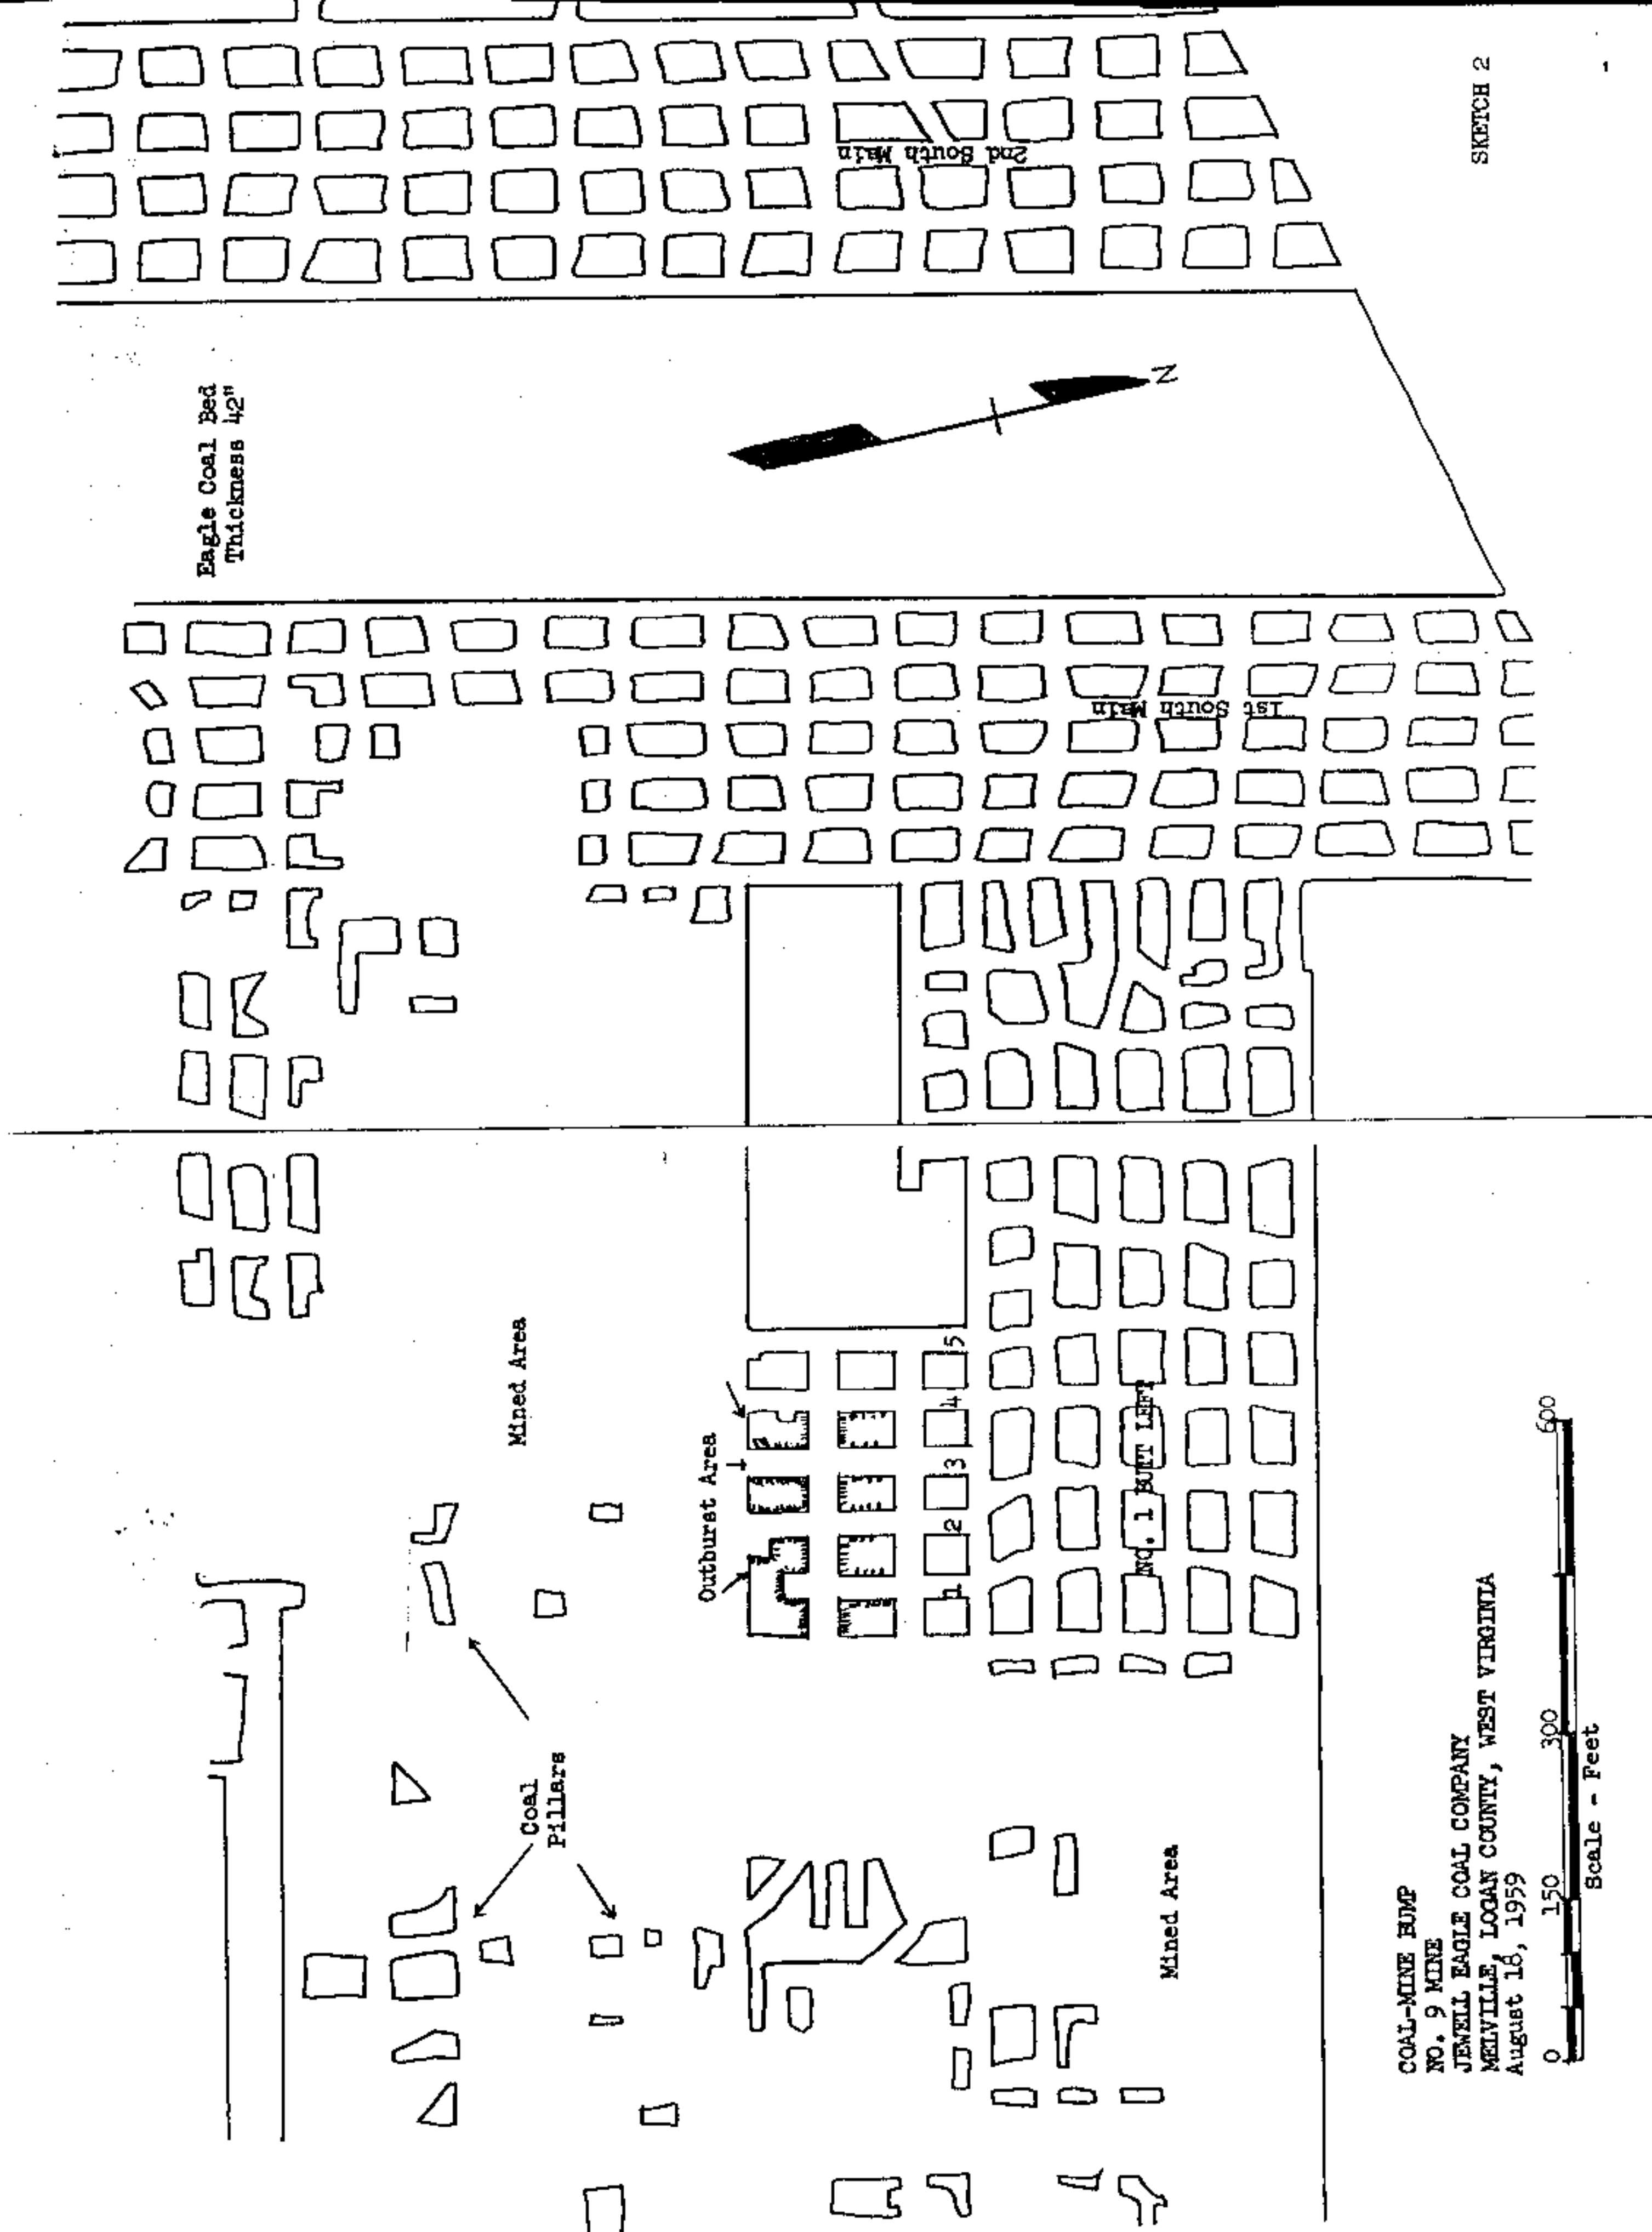
SKETCH 2

The system of development and extraction utilized in 1 butt left is shown in Sketch 2. The 1 butt left entry pillars were about 40 feet in width and 60 feet in length. The rooms involved were driven 20 to 32 feet in width, thus making the blocks (pillars) 28 to 40 feet in width and about 40 to 60 feet in length. The individual pillars are extracted by taking successive open-end lifts, 20 to 25 feet in width, across the back side of the pillars from the entry side of the entry chain pillars and from the room side of the room pillars; however, in some instances, the last lift (usually a push-out) is completed from the crosscut side of the pillars. After completion of the pillars in a panel of 5 rooms,

the entry-chain pillars are extracted to a point opposite the No. 5 room then another panel of 5 rooms is developed, as illustrated in Sketch 2. This system eventually establishes approximately a flat extraction line, but in the process development of rooms such as in the 1 butt left section is toward the gob in an abutment zone, and in some instances probably superimposed from 2 mined-out areas. (Old gob area from 2 butt left and the recently mined-out inby panel of rooms.)
